THIS IS AN IMPORTANT NOTICE!
PLEASE REVIEW AND RESPOND – 1st Notice
IMMEDIATE RESPONSE REQUESTED

Model 106 Generators: Device Disablement

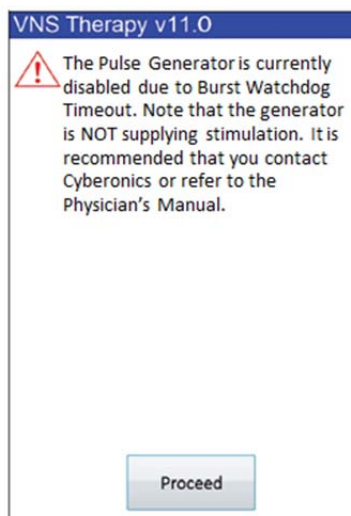
Due to unintended behavior in the Model 106 AspireSR generator software, the generator can stop delivering stimulation unexpectedly. This event can only occur when a rare combination of circumstances are present, one of which is when the AutoStim Output Current is programmed greater than or equal to the Magnet Output Current. Stimulation can be reinitiated at the next office visit by programming stimulation output current on.

The programming computer will display a message (shown in Figure 1), upon interrogation of the generator following this event.

Figure 1 – Error message displayed upon interrogation of M106 Generator after event

If it is identified that a patient's generator has been disabled due to this condition, please contact Clinical Technical Support at 866-882-8804 to report the event. The generator output currents for Normal, Magnet, and AutoStim should be programmed back on (i.e., greater than 0 mA) to resume therapy, following the programming recommendations presented in Figure 2 to prevent recurrence of the issue.

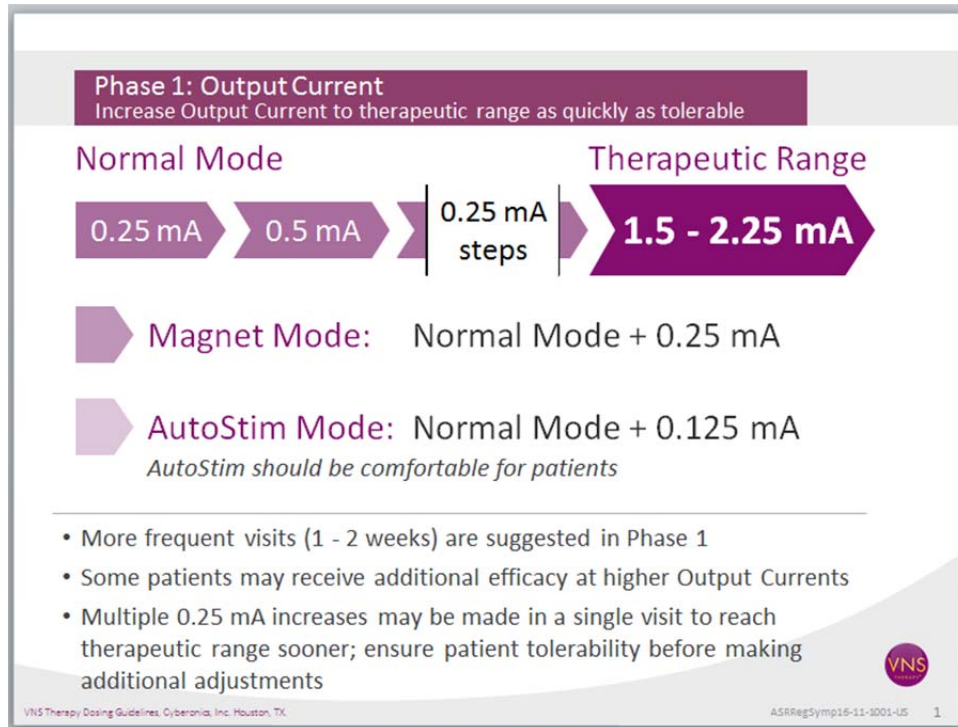
This issue is preventable by following programming recommendations provided in Cyberonics' Physician Training Material (see Figure 2, VNS Therapy Dosing Guidelines). **If a Model 106 generator is programmed with the Magnet Output Current greater than the AutoStim Output Current, this condition will not occur.** No action is needed for those patients already programmed in this manner.

Figure 2 – VNS Therapy Dosing Guidelines
